SF Technical Bulletin

C3W9PD & MVC9000x Series Water Ingress Issue

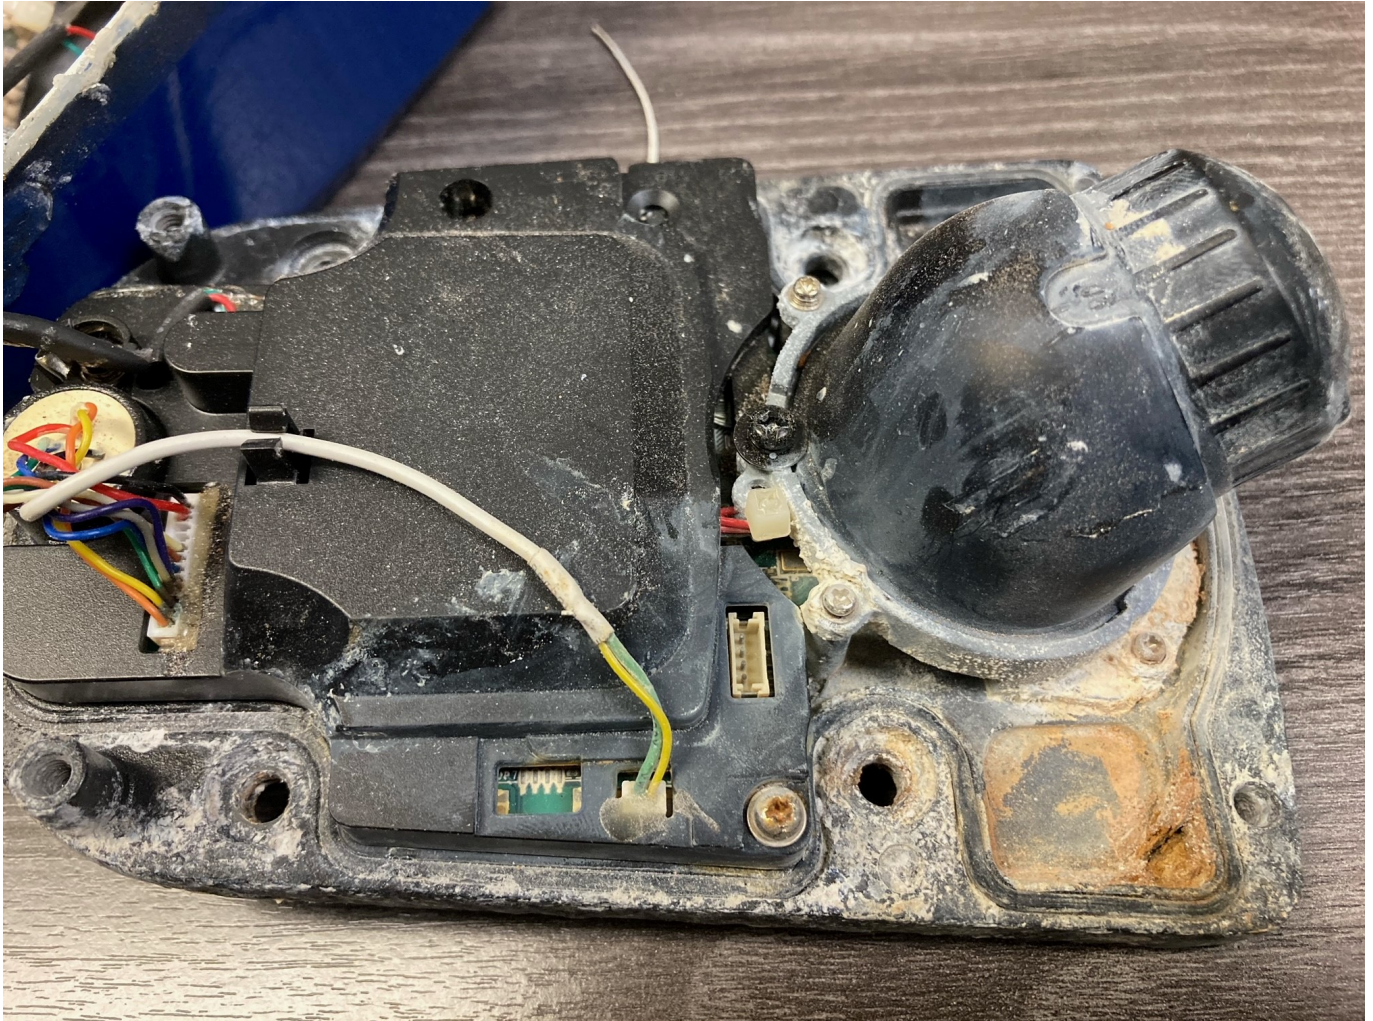
There have been some reports of water leaking into the C3W9PD IP cameras, causing damage to its internal components. In those instances, our engineers suspected that there was a pinched or obstructed sealing gasket along the base plate.

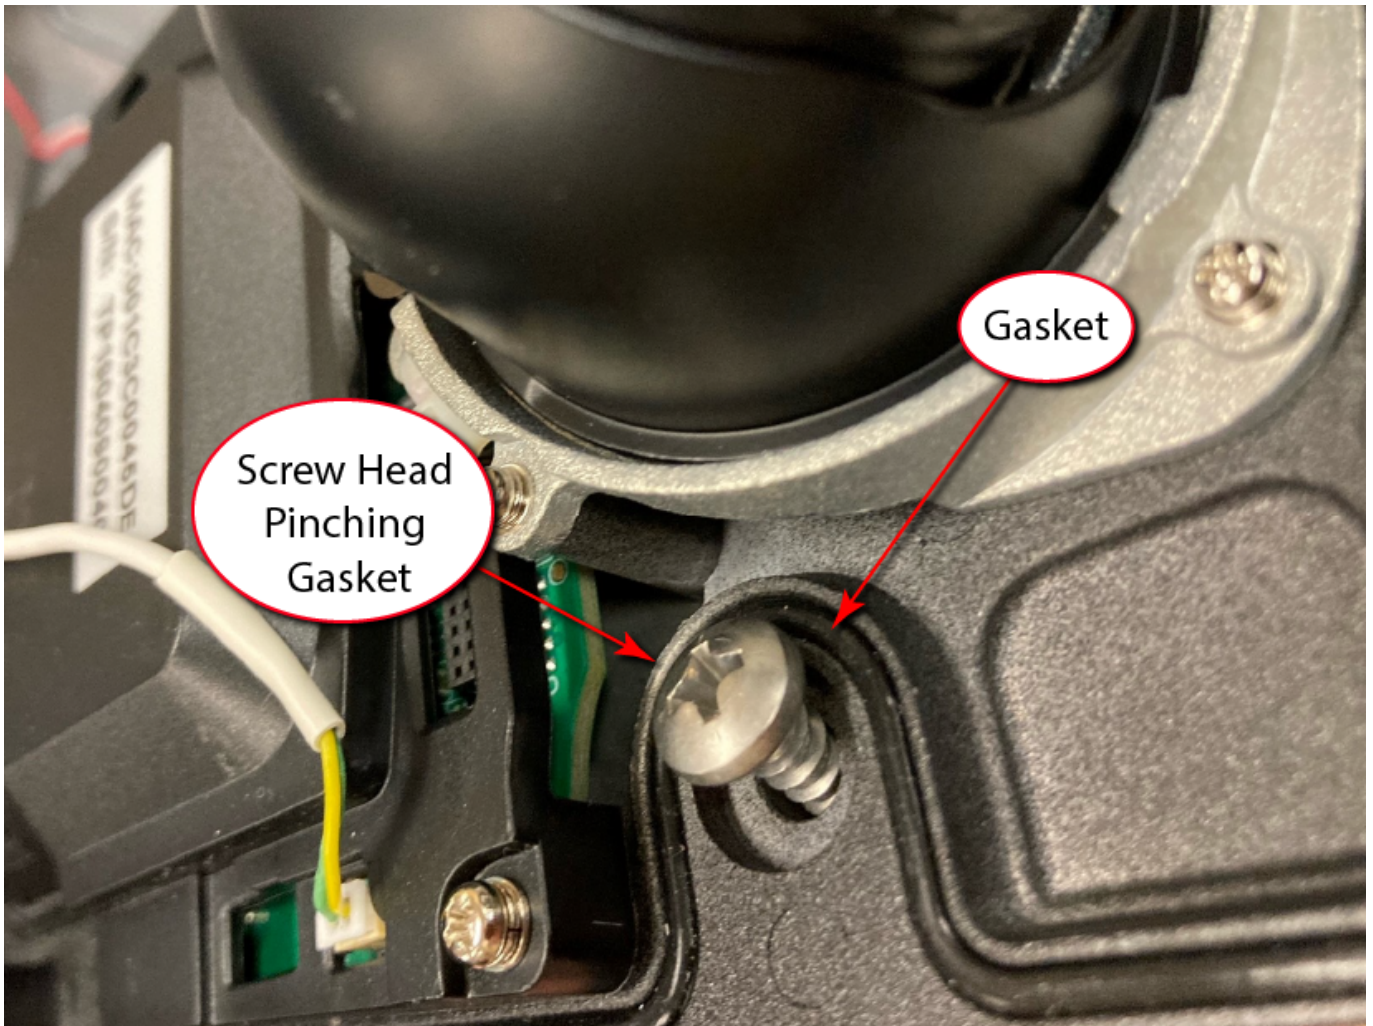
Avoid oversized screw heads

We recommend using the supplied #10, 1" mounting screws. While this suits most installations, different-sized screws may be required for specific vehicles. If you use a different sized screw, you must ensure the screw head does not contact the base plate gasket.

Avoid drilling/screwing at an angle

When fully-inserted, the screw heads must sit flush with the countersunk holes in the mounting base. Do not drill/thread the mounting screws at an angle or off-center, as this can pinch or obstruct the base plate gasket.
