# **Bulletin: C3W MVC900x Water Ingress**

# **SF Technical Bulletin**

# C3W9PD & MVC9000x Series Water Ingress Issue

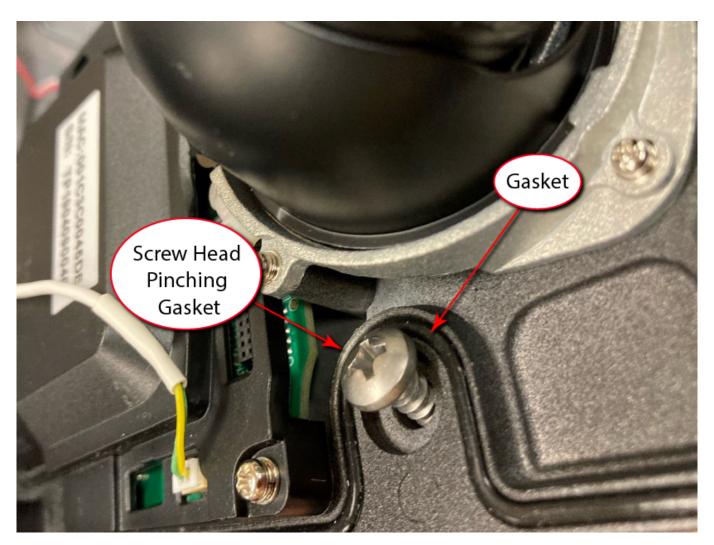
There have been some reports of water leaking into the C3W9PD IP cameras, causing damage to its internal components. In those instances, our engineers suspected that there was a pinched or obstructed sealing gasket along the base plate.

We recommend using the supplied #10, 1" mounting screws. While this suits most installations, different-sized screws may be required for specific vehicles. If you use a different sized screw, you must ensure the screw head does not contact the base plate gasket.

When fully-inserted, the screw heads must sit flush with the countersunk holes in the mounting base. Do not drill/thread the mounting screws at an angle or off-center, as this can pinch or obstruct the base plate gasket.
